Wild Fish Conservancy Watertype Assessment Project Summary

West Sound Watersheds Phase I

May 2013

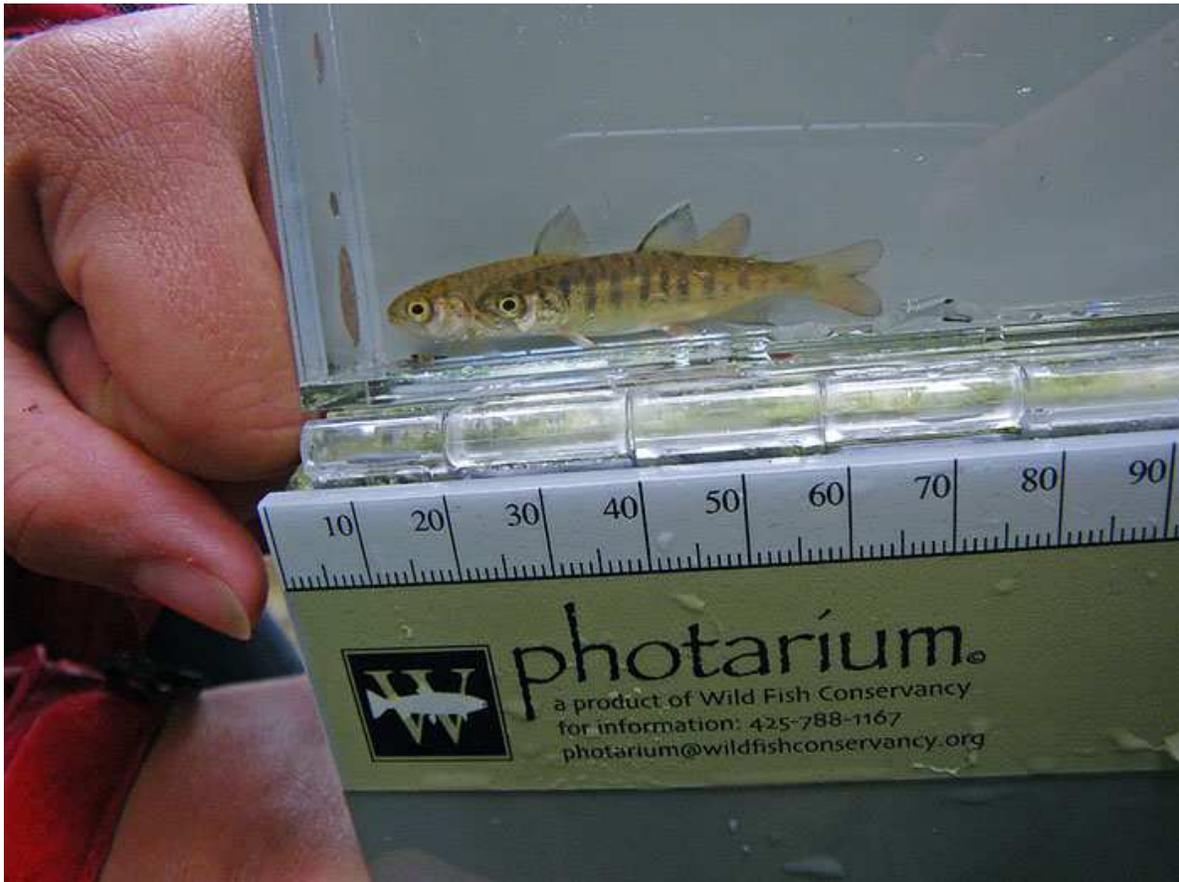
Figure 3. Juvenile coho salmon captured in Cowling Creek downstream from several barrier culverts.

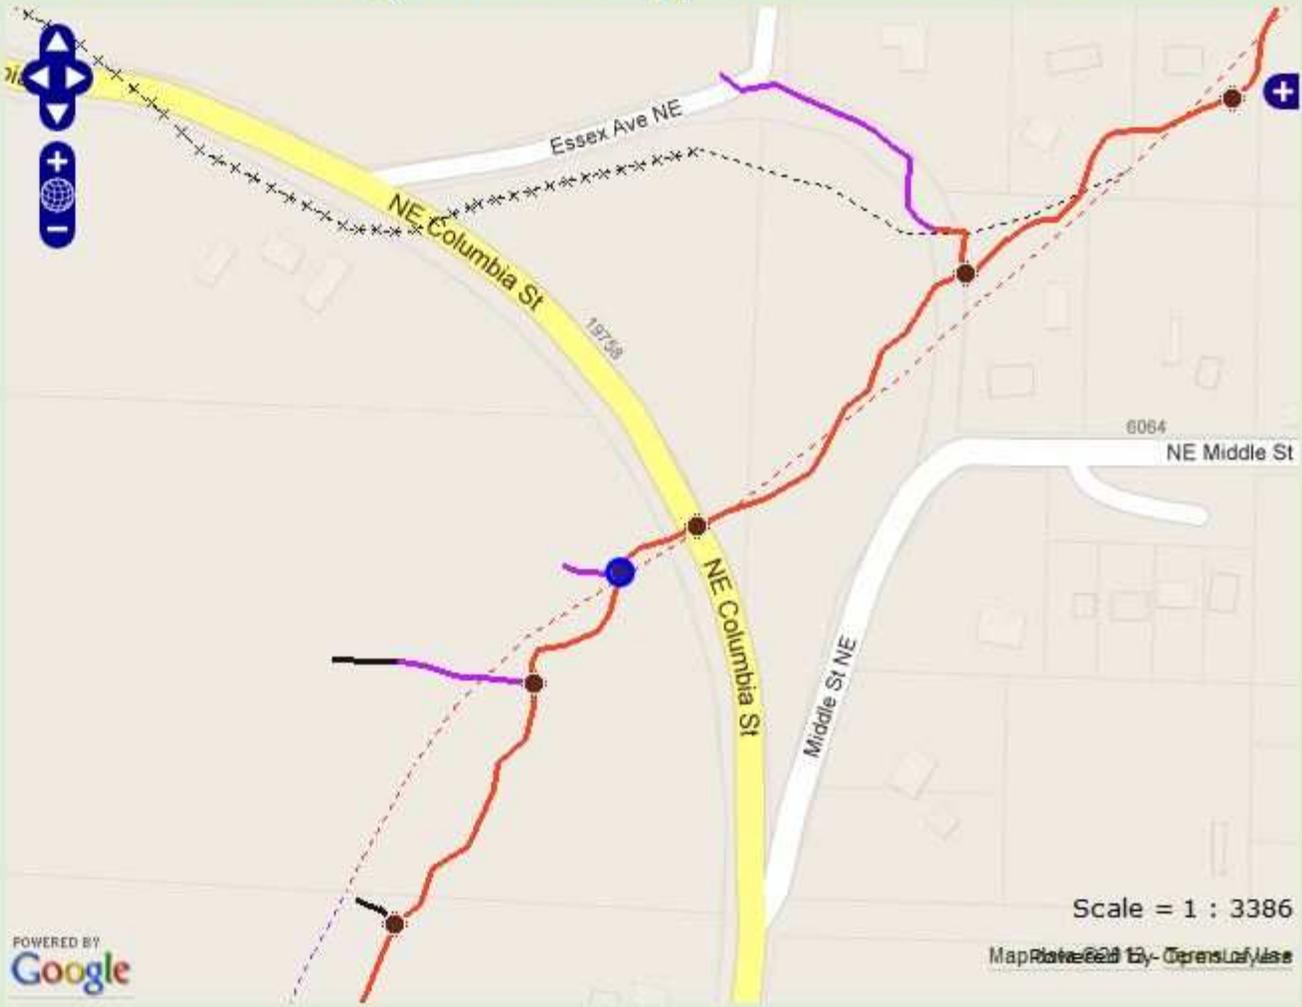
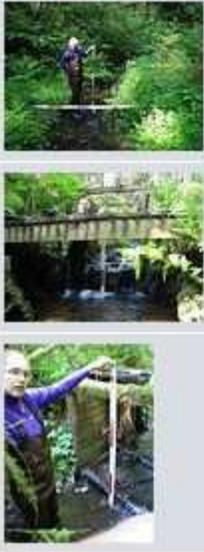
Map and photos for Project ID “B.” The blue dot represents the project location. Additional details are available on the interactive map site at: www.wildfishconservancy.org

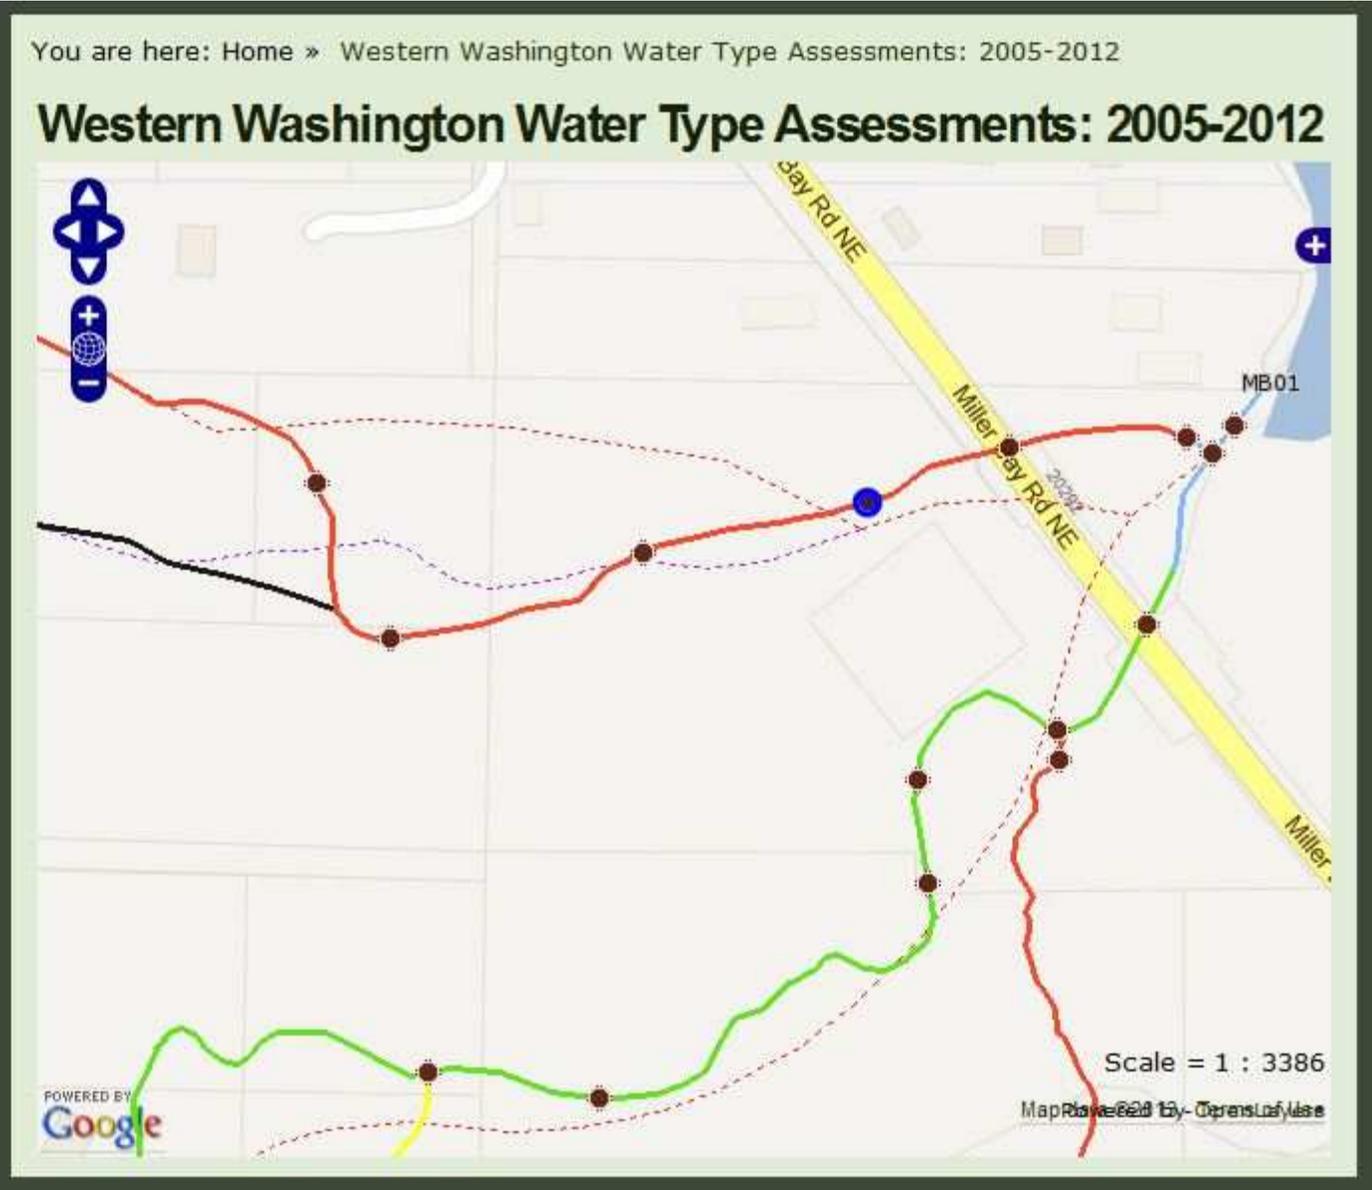
Map and photos for Project ID “C.” The blue dot represents the project location. Additional details are available on the interactive map site at: www.wildfishconservancy.org
